New Hampshire Volunteer Lake Assessment Program

2002 Interim Report for Rockwood Pond Fitzwilliam

Rockwood Pond, Fitzwilliam

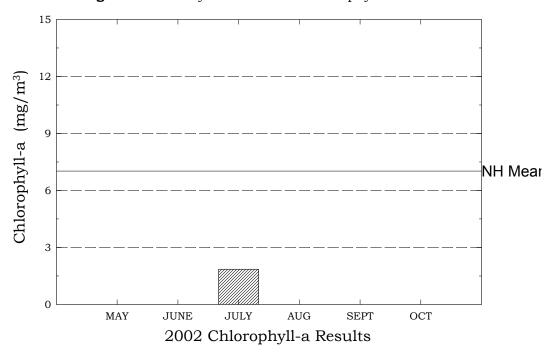
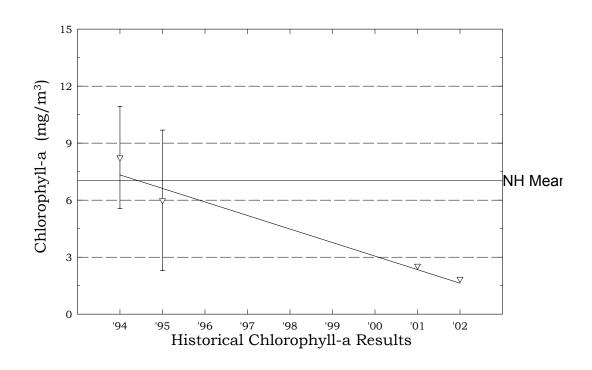
Figure 1. Monthly and Historical Chlorophyll-a Results

Figure 1 and Table 1: The graphs in Figure 1 (Appendix A) show the historical and current year chlorophyll-a concentration in the water column. Table 1 (Appendix B) lists the maximum, minimum, and mean concentration for each sampling season that the lake/pond has been monitored through the program.

The current year data (the upper graph) show that the chlorophyll-a concentration in July was *much less than* the state mean.

Overall, visual inspection of the historical data trend line (the bottom graph) shows **a decreasing** in-lake chlorophyll-a trend, meaning that the concentration has **improved** since monitoring began in 1994. However, since the pond was not sampled during 1996 – 2000, it is important to note that this trend is based on a limited data set.

While algae are naturally present in all lakes/ponds, an excessive or increasing amount of any type is not welcomed. In freshwater lakes/ponds, phosphorus is the nutrient that algae depend upon for growth. Therefore, algal concentrations may increase when there is an increase in nonpoint sources of nutrient loading from the watershed, or in-lake sources of phosphorus loading (such as phosphorus releases from the sediments). It is important to continually educate residents about how activities within the watershed can affect phosphorus loading and lake quality.

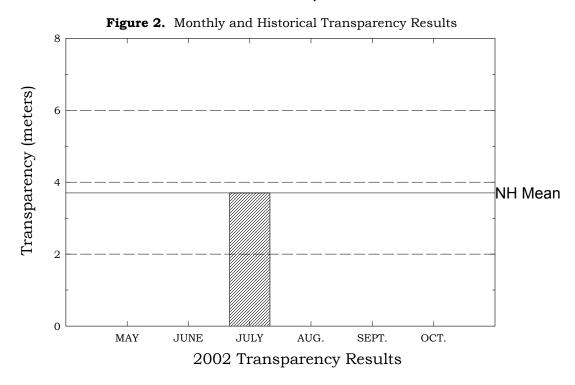
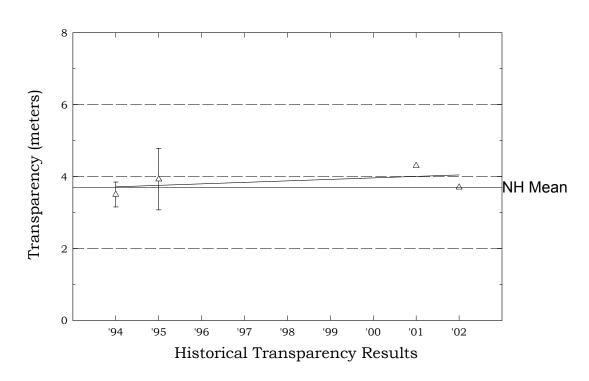
Figure 2 and Table 3: The graphs in Figure 2 (Appendix A) show historical and current year data for lake/pond transparency. Table 3 lists the maximum, minimum and mean transparency data for each

The current year data (the upper graph) show that the transparency in July was **approximately equal to** the state mean.

Overall, visual inspection of the historical data trend line (the bottom graph) shows **a slightly increasing** trend for in-lake transparency, meaning that the transparency has **slightly improved** since monitoring began in 1994. Again, please remember that this trend is based on a limited data set. As your association expands its monitoring program to include additional sampling events per season, we will be able to determine long-term trends with more accuracy and confidence.

Typically, high intensity rainfall causes erosion of sediments into the lake/pond and streams, thus decreasing clarity. Efforts should continually be made to stabilize stream banks, lake/pond shorelines, disturbed soils within the watershed, and especially dirt roads located immediately adjacent to the edge of tributaries and the lake/pond. Guides to Best Management Practices designed to reduce, and

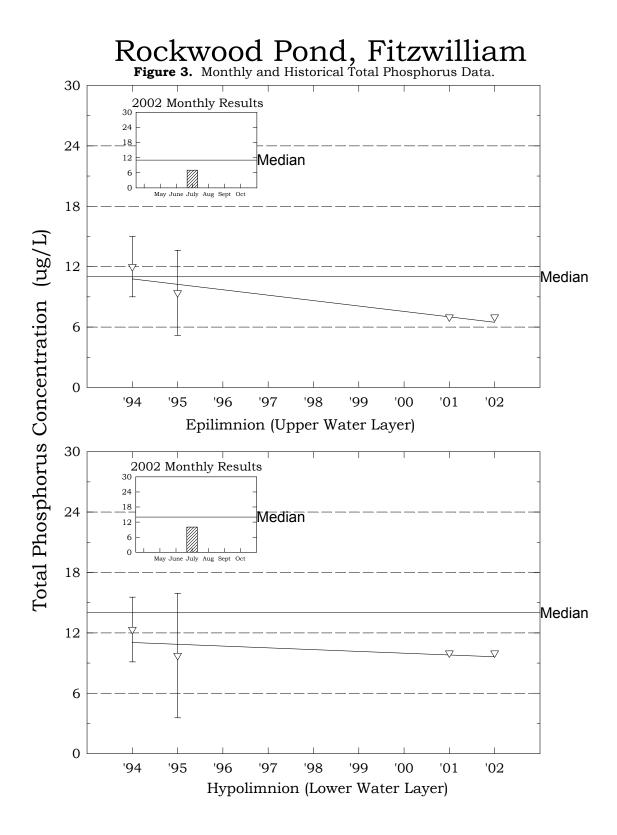
Figure 3 and Table 8: The graphs in Figure 3 (Appendix A) show the amounts of phosphorus in the epilimnion (the upper layer) and the hypolimnion (the lower layer); the inset graphs show current year data. Table 8 (Appendix B) lists the annual maximum, minimum, and median concentration for each deep spot layer and each tributary since the lake/pond has joined the program.

The current year data for the epilimnion (upper layer) and the hypolimnion (the lower layer) show that the total phosphorus concentration in July was *less than* the state median

Overall, visual inspection of the historical data trend line for the epilimnion and the hypolimnion shows **a slightly decreasing** phosphorus trend, which means that the concentration has **slightly improved** since monitoring began. We hope this continues!

One of the most important approaches to reducing phosphorus loading to a waterbody is to continually educate watershed residents about its sources and how excessive amounts can adversely impact the ecology and value of lakes and ponds. Phosphorus sources within a lake or pond's watershed typically include septic systems, animal waste, lawn fertilizer, road and construction erosion, and natural wetlands. If you would like to educate watershed residents about how they can help to reduce phosphorus loading into the lake/pond, please contact the VLAP Coordinator.
